Fortress Machinery Appraisals & Consulting

Unidentifiable Example Asset Appraisals for Illustration Purposes Only

Asset Description for: Example Appraisals

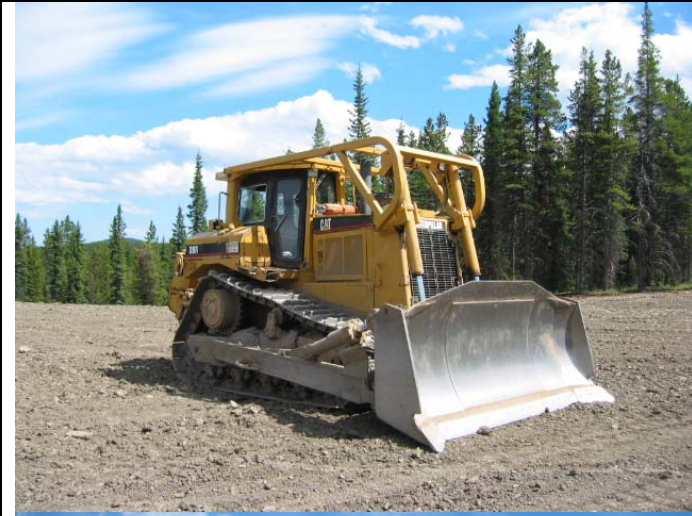
Verified Year: 1997
Make: Caterpillar
Model: D8R Crawler Tractor
Condition: Good
Serial Number: **7XM00000**
Unit: 0000

Description: 3,995 Hours, Caterpillar 3406B diesel engine, s/n 00000, 305 HP with emergency engine shutdown device, powershift transmission and differential steering. EROPS cab with climate control. 24" extreme service track shoes on eight roller track frames. Heavy duty radiator guard, oilfield guarding package, engine side guards, battery box and hydraulic tank guards, transmission guard and fuel tank guard. Caterpillar 8SU (semi universal) bulldozer blade with single tilt cylinder and spill plate. Caterpillar #8 single shank adjustable ripper with hydraulic pin puller, S/N 1FH00000 and deep ripping shank. Fire and safety equipment.

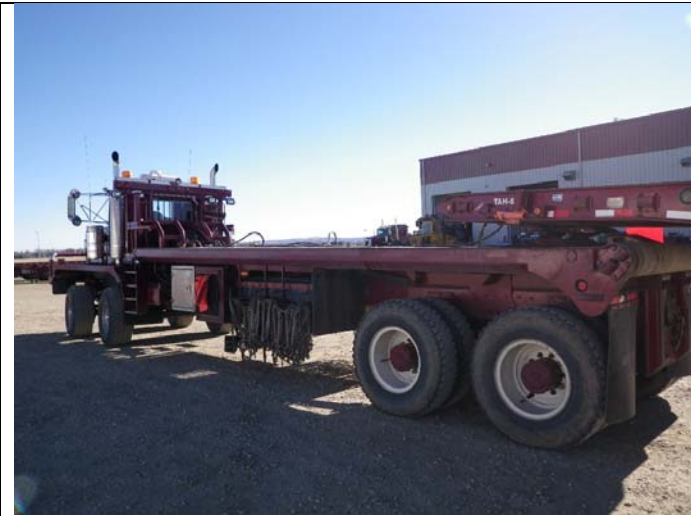
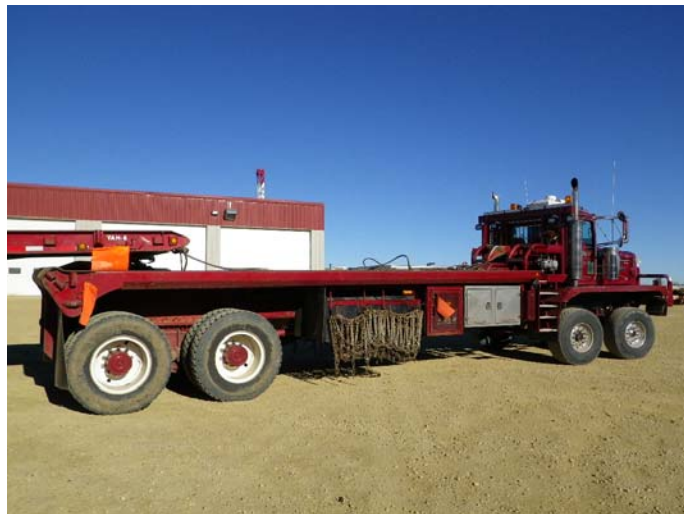
Verified Year: 2007
Make: Kenworth
Model: C500B Tandem -Tandem Planetary Bed Truck
Condition: Very Good
Serial Number:
1NKCX4TX87R000000
Unit #: 0000

Description: 5,891 Hours, 196,297 KM, Cummins ISX- 450 diesel engine, 450 HP, serial number 00000000, emergency shutdown device, engine brake and Alison 4500 RDS automatic five speed transmission. Tandem 36,000 LB front axles with 72" axle spacing, SISU FR2P-32-S planetary 65,000 LB rear axles, equalizer suspension, 60" axle spacing and 350" wheelbase with setback. Air conditioning, stereo and axle lockers. Front aluminum budd wheels on 445/65R x 22.5 tires and rear heavy duty steel wheels on 1200 x 24 tires. 9' 6" x 28' heavy duty oilfield bed, poles, pole kickers, hideaway 5th wheel, rear live roll and tail skirt. Braden hydraulic main and auxiliary winches. Heavy duty oilfield bumper.

Steel headache rack, steps and toolboxes. Fire and safety equipment. Alberta CVIP certification date.
